Kidde Technologies Inc.
4200 Airport Road
Wilson, NC 27896
Phone:
Email:
www.kiddetechnologies.com

Subject: Product improvement/cost savings - New Kidde manual discharge switch tamper seal solution

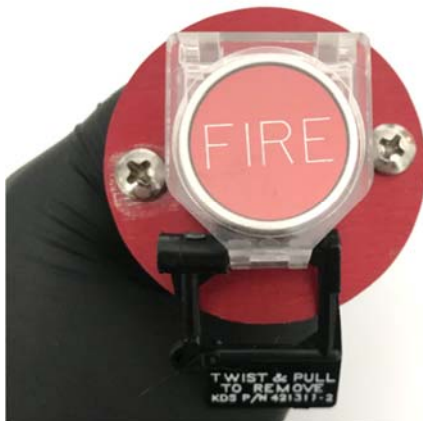
Figure 1

In our continuing effort to improve our products, we are changing the current tamper seal configuration (**Figure 1**) to a new tamper seal solution (**Figure 2**) for our manual discharge switch. This new solution prevents the possibility of the tamper seal breaking in the wrong location if improperly removed. Furthermore, the new tamper seal, reduces the cost of tamper seal replacement. All new purchased buses installed with our system will have this new tamper seal configuration.

The conversion kit, part #477545 (**Figure 3**), converts a Kidde manual discharge switch that is configured to use the old tamper seal solution (Figure 1) to the new tamper seal configuration (Figure 2). Going forward when you order Kidde's old tamper seal, part #421317-2, you will receive the conversion kit instead. The cost of the conversion kit will be the same as ordering the replacement tamper seal. We recommend that you install this kit during one of your maintenance actions.

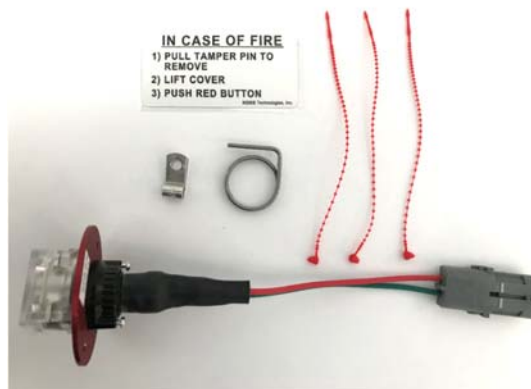
Figure 4

The complete manual discharge kit part number is changing to 477544 (**see Figure 4**). This part number replaces 421317 going forward.
